A Code of Practice

For prior to purchase
timber pest inspections

Prior to Purchase Timber Pest Inspection

CODE OF PRACTICE

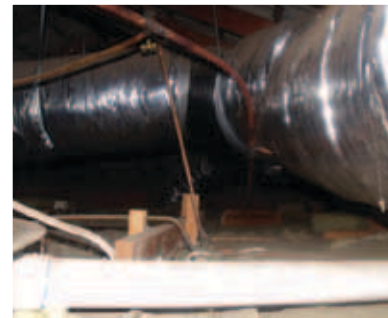
Example of access limitations in roof void.

A Timber Pest Inspector cannot work where there are unresolved safety issues. A Timber Pest Inspector needs space in which to work. Under a floor, with no debris, the minimum vertical clearance is usually 40 cm but may be 50 cm if there are protrusions (such as concrete form work). Ceilings and external walls are inspected only as far as can be reached by a 3.6 metre ladder or 2.1 metre step ladder unless prior agreement and special provisions are made. For access into a roof void, an entry of at least 45 cm by 40 cm is required and the vertical working clearance is set at 60 cm. The construction of the roof (inadequate clearances, low pitch or widely spaced framing) may also create access limitations. (Further access limitations are discussed in Section 11.4).

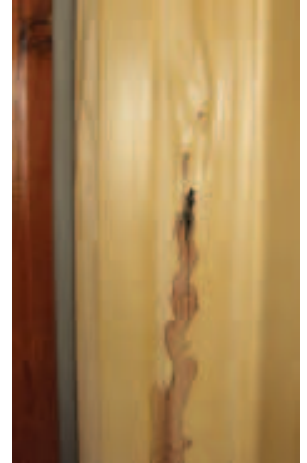
Live termites are usually concealed within the timber or their mud leads. They can sometimes be exposed after conducting a probing or splinter test on termite damaged timber or mud leads and galleries but often they cannot be shown without undertaking an invasive inspection.
